MONITORING AND METHODS OF ENSURING THE SAFETY OF LONG-SPAN POST-TENSIONED SLABS

Rafał Szydłowski¹ and Barbara Łabuzek²

^{1,2} Faculty of Civil Engineering, Cracow University of Technology, Cracow, Poland

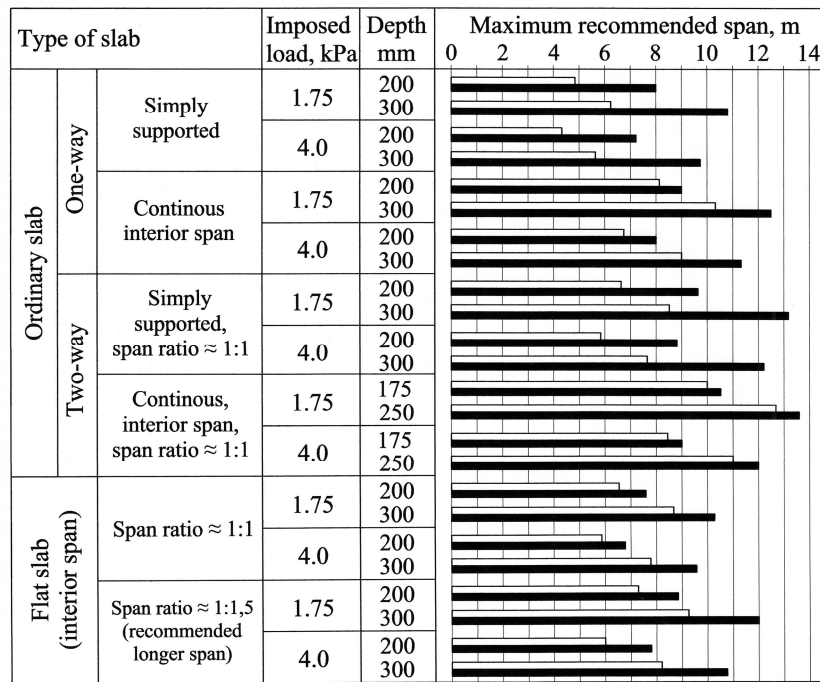
Figure 1. Examples of slab thickness and indication of maximum span for solid slabs with ordinary (□) and prestressed (■) reinforcement according to fib Bulletin 31 (2005).

Khan and Williams (1994), basing on the crack free condition, and basing on the performed calculations give the required depth to span ratio for the various load levels (Table 1). Moreover, in the fib Bulletin 31 (2005), the minimum slab depth and maximum slab span for various support conditions and load levels are listed in a more detailed way. Generally, the highest span to depth ratios identified according to these recommendations do not exceed the value of 45. The allowed recommended span lengths (Fig. 1) according to fib Bulletin 31 (2005) for continuous slabs are equal to 13.6m for two-way slabs and to 12.5m for one-way slabs. The published recommendations resulted in that the solid cross-section slabs are erected with maximum span limit set around 12÷13m all over the world.

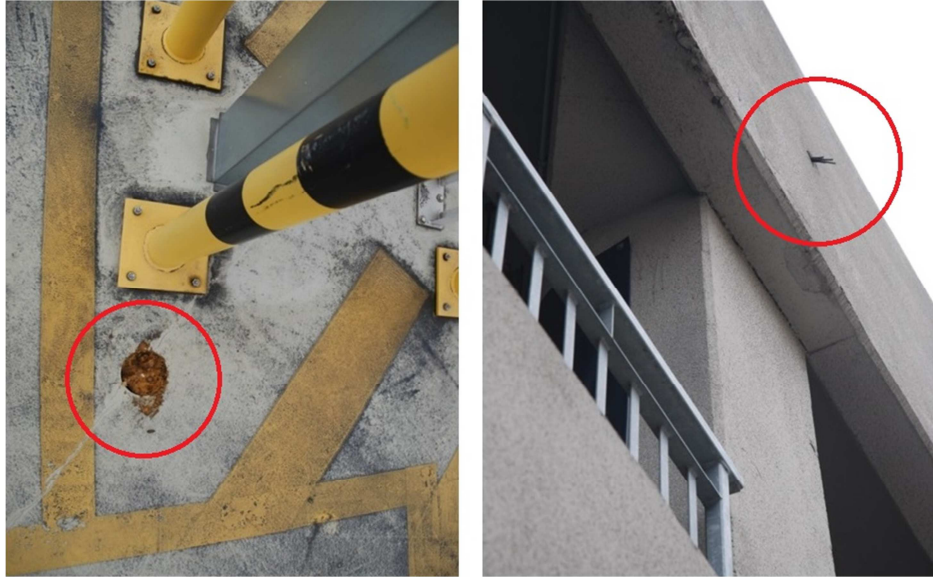
The example of unbonded tendon failure is shown in Figure 2. Cutting of the tendon during core drilling has caused puncturing of the external plaster and launching of the tendon from the structure.

Figure 2. The intersection of the strand in the borehole (left picture) and its launch from the structure (right picture).

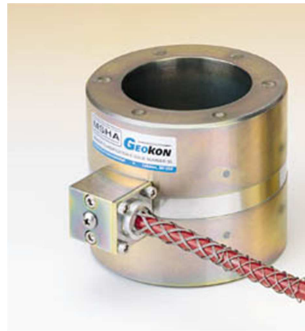
The sleeve sensors mounted under the anchorages (Fig. 5) are used to measure the force in prestressing tendons. Three vibrating wires, located every 120°, are mounted in the sensor wall. The magnitude of the force is determined based on the average of vibration frequencies in all three vibrating wires.

Figure 5. Construction of a typical vibrating wire deformation transducer.

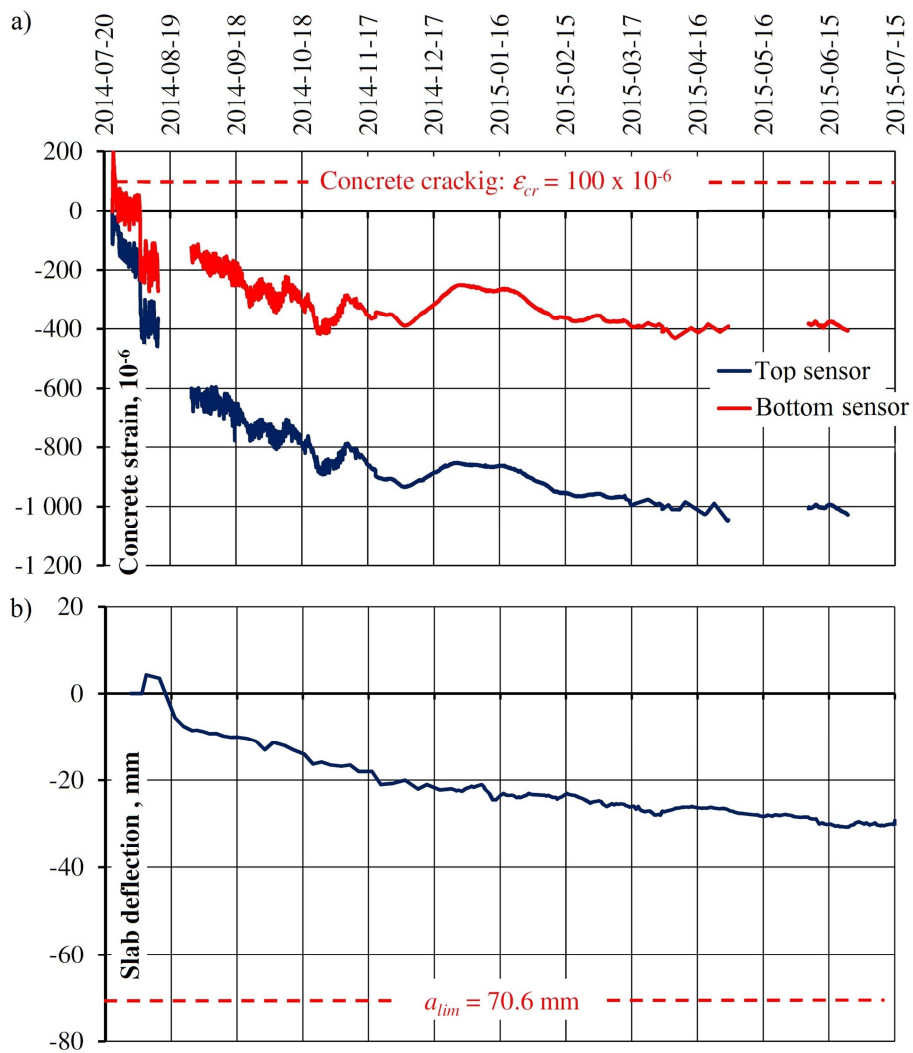
Figure 11a shows the development of strain in the mid-span cross-section in the direction of the

Figure 11. Development of concrete strains in the mid-span cross-section (a) and slab deflection (b) over first year of slab life.

shorter span for the first year. A leap in the first month was caused by prestressing. Further, creep and shrinkage increased concrete strain. After seven months, concrete strains stabilized. The presented results indicate that concrete did not extend which means lack of decompression and maintenance of level III stresses. Increase of strains difference between the top and bottom surface corresponds with the growth of deflection shown in Figure 11b. At the end of continuous monitoring, a deflection of about 30mm was obtained, which is 1/587 of the span.

Maintenance of the compressed cross-section (lack of decompression) was reflected in the value of deflection after four years since slab erection. Total deflection after four years is 54.5mm. The deflection increases since disassembly of formwork (important for brittle elements under and above slab) is 47.5mm. The registered deflection seems to be high but it should be noted that span slab is equal to 17.6m in the shorter direction. The growth of deflection is 1/371 of span. In accordance with Eurocode 2 the limit value of deflection for that slabs is $L/250$ (if there are no brittle elements on the slab). It is important that the growth of deflection in the last year was 4.5mm, whereas in the previous year it was 7.5mm. Moreover, after three years, the creep, which is one of the main reasons of increased deflection in time, occurs in 80%. Both of these facts lead to the discovery that the limit $L/250$ will never be achieved.
